# Screening of concrete additives

Naturvårdsverket

<b>Title</b>	Screening av betongtillsatser
<b>Version</b>	003
<b>Date</b>	Jan 10, 2014
<b>Client</b>	Naturvårdsverket
<b>Project number</b>	1003-05
<b>Document number</b>	1003-05\10\01\Report_screening_concrete english.docx
<b>Report written by</b>	Niklas Hanson & Helena Norin
<b>Report reviewed by</b>	Åke Larsson
<b>Report verified by</b>	Helena Norin

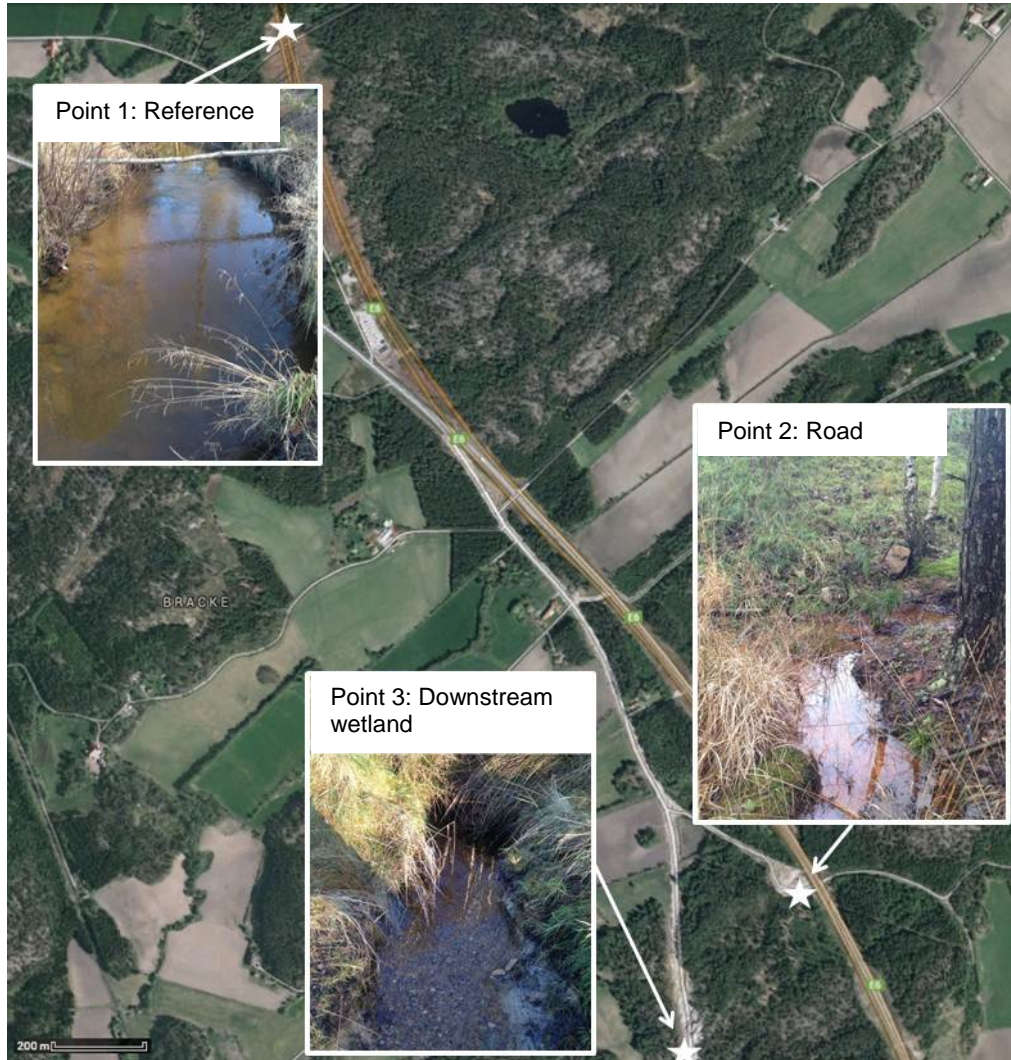
Figure 1. Samples were taken at three points, to investigate leaching and spread of concrete additives from the road construction. Point 1 is a reference point upstream that has not been affected by the recycled concrete. Point 2 was selected to be as close to the recycled concrete as possible. Point 3 was located approx. 300m from the concrete road construction.

During motorway construction north of Tanumshede, a bridge was demolished. The concrete from the bridge was crushed to be used in a road bank for a new bridge over the E6 motorway. The original concrete bridge base was formed in 1995 and the concrete was torn down in early summer 2010 and placed directly in the new road construction. The concrete now lies beneath the surface asphalt and above the groundwater level. Two samples were taken from potentially contaminated points and at a reference point. Potentially contaminated samples were taken at two distances from the recycled concrete (Figure 1). One point was selected to be as close to the concrete as possible (Point 2), with a maximum chance of reaching high levels. The other point was placed downstream from the wetland that received water from the road (Point 3). The reference sample was taken further north, close to the road where recycled concrete had not been used (Point 1).

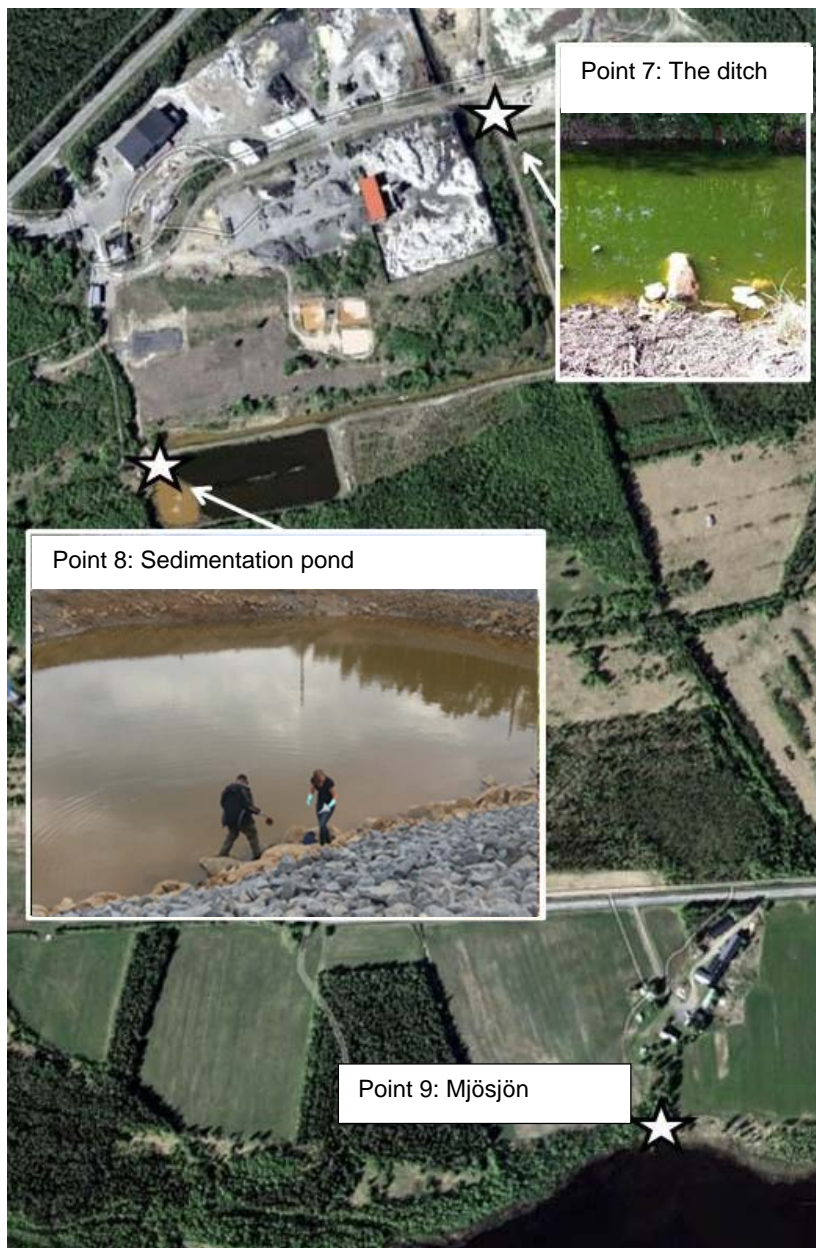
Figure 3. Three samples were taken at Brännkläppen landfill, of which two were within the landfill site and one in Mjösjön, the receiving water for leachate from the landfill.

screening programme. Three samples were taken on and beside the landfill. The sampling points were located in a leachate ditch at the landfill site (Point 7), in a sedimentation pond (Point 8) and in the receiving water (Point 9) The receiving water was a lake (Mjösjön) where the leachate ends up after passing through a wetland.

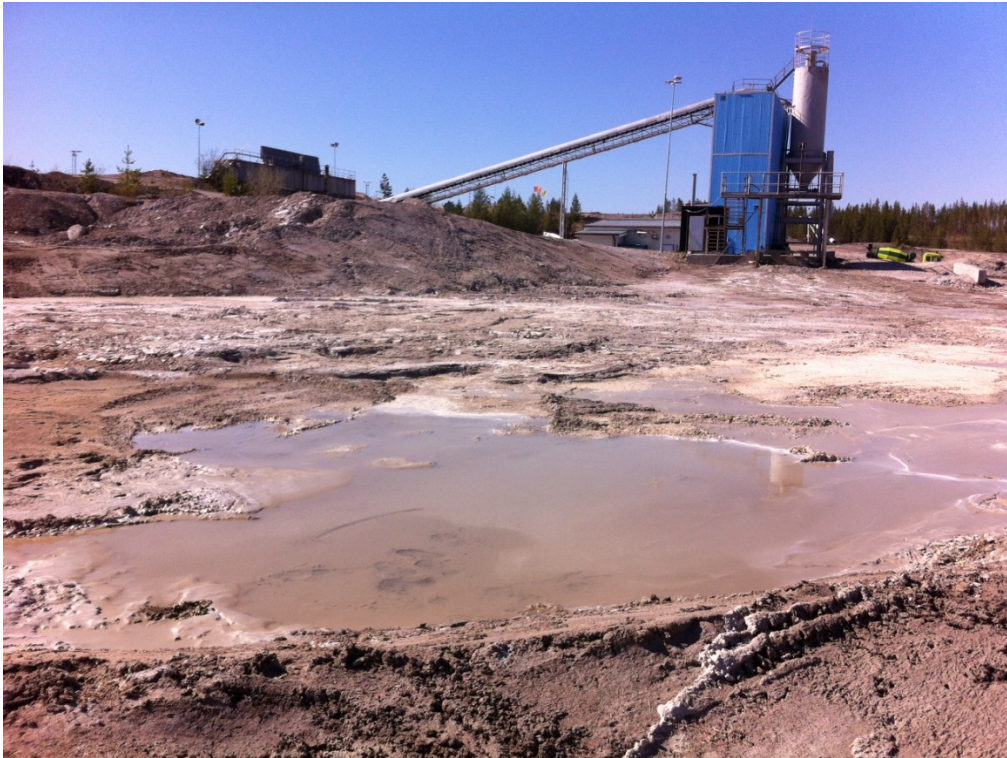
Figure 4. *Sampling point at the wash pond at Skanska’s concrete plant, where the water from concrete lorries is collected after the lorries’ concrete tanks have been cleaned.*

Norrbottn County Administrative Board carried out sampling at Skanska’s plant in Luleå. The plant produces concrete which is distributed mainly in the Luleå area by lorry. The lorries are cleaned daily at the end of each shift. Sampling was carried out in a wash pond (Point 10) where the water from concrete lorries is collected after the lorries’ tanks have been cleaned. At sampling the cleaning had not been started that day, meaning that the water from the day before was left in the pond. Skanska supplied material safety data sheets for Portland cement and additives to allow a comparison of sampling results with the substances used in concrete production.

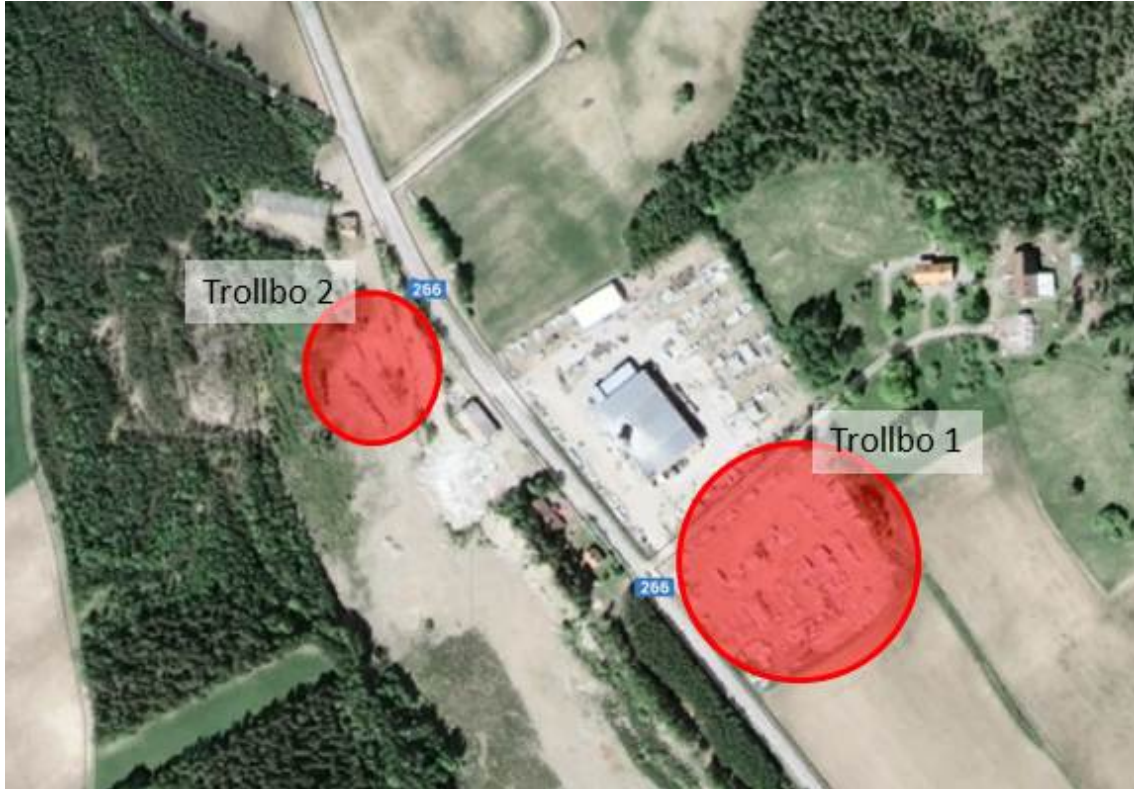
Figure 5. There are two landfill sites at Trollbo, on either side of Highway 266. These are designated Trollbo 1 and Trollbo 2, as in the figure.

The Dalarna County Administrative Board conducted sampling at an industrial landfill in Säter (Trollbo). The landfill is situated on both sides of Highway 266, and designated as Trollbo 1 (Point 11) and Trollbo 2 (Point 12). Sampling was carried out on 4/12/2012.
